First Five-Year Review Report

**Reilly Tar and Chemical Corp. (Dover Plant),
Dover, Ohio**

June, 2005

**United States Environmental Protection Agency
Region 5
Chicago, Illinois**

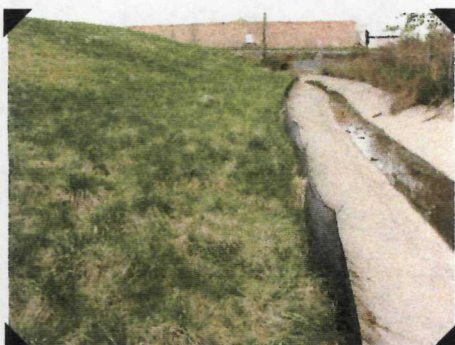
Lined ditch facing north towards town, note slope of site into ditch

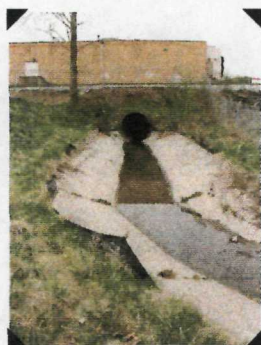
Lined ditch facing north towards town

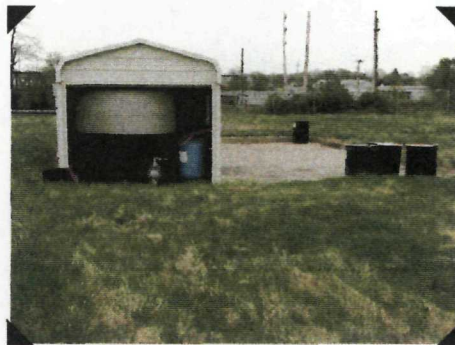
Back side of pump house with coal tar drums stored on pad.

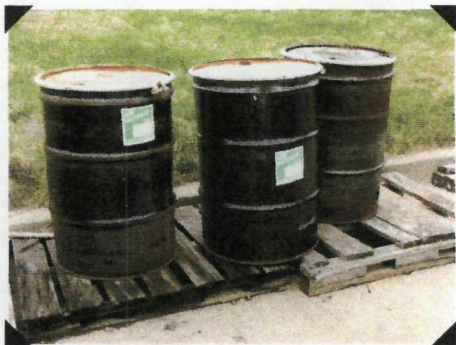
55 gallon drums of coal tar stored onsite near pump house

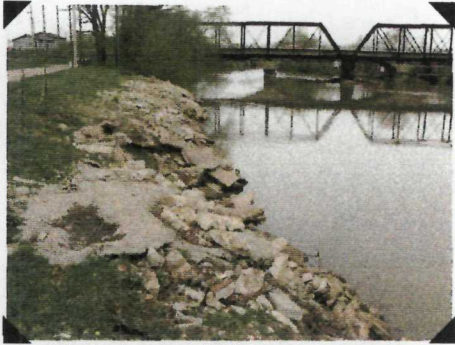
Tuscarawas River, bank erosion and bridge

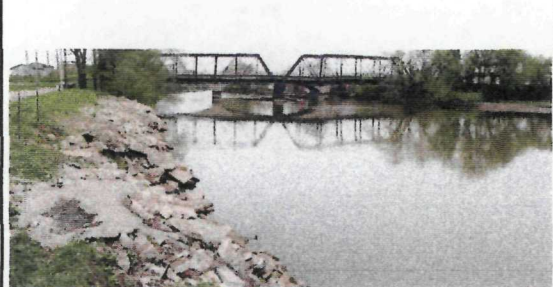
Panorama of Tuscarawas River, bank erosion and bridge

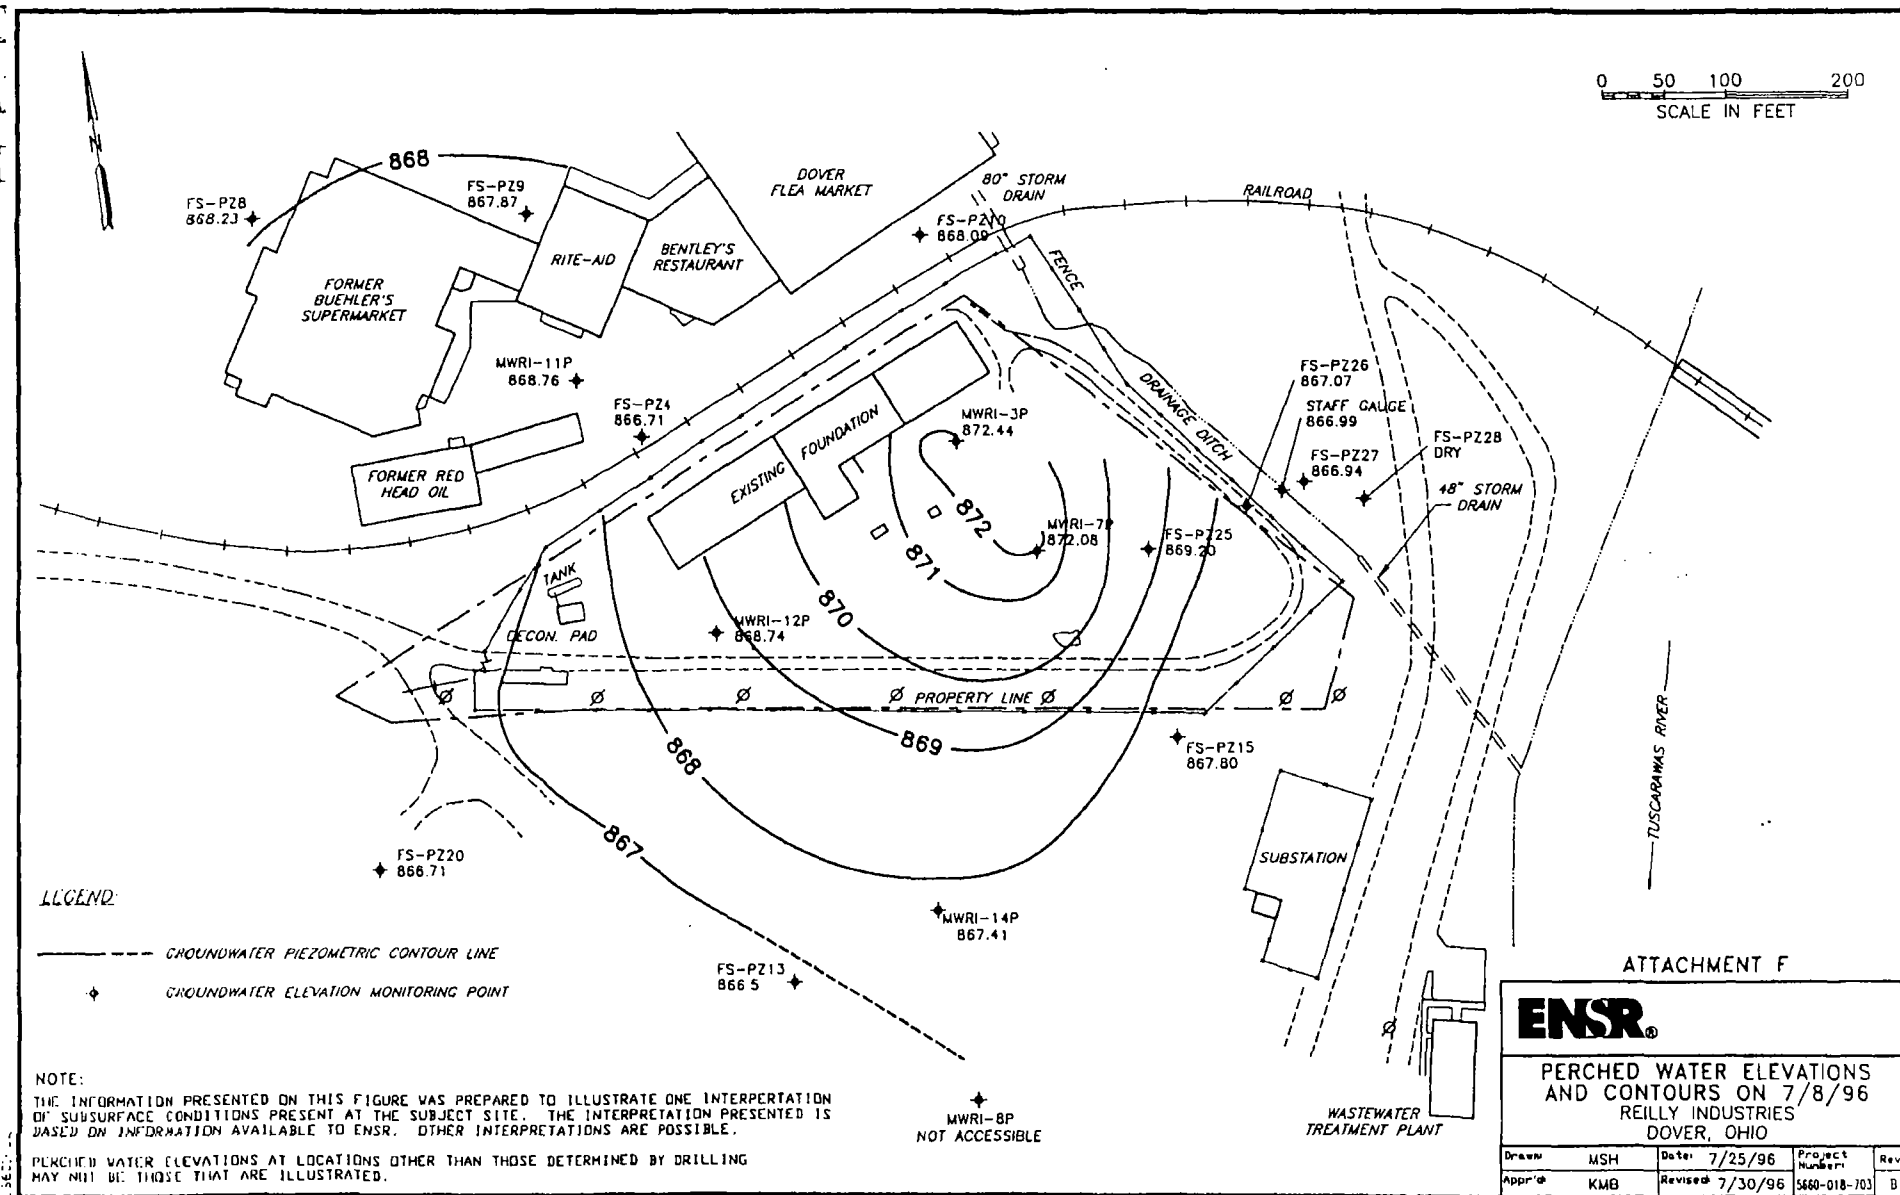
Figure B—Perched groundwater head map from Technical Memorandum of 1996. Note southeast quadrant of property.

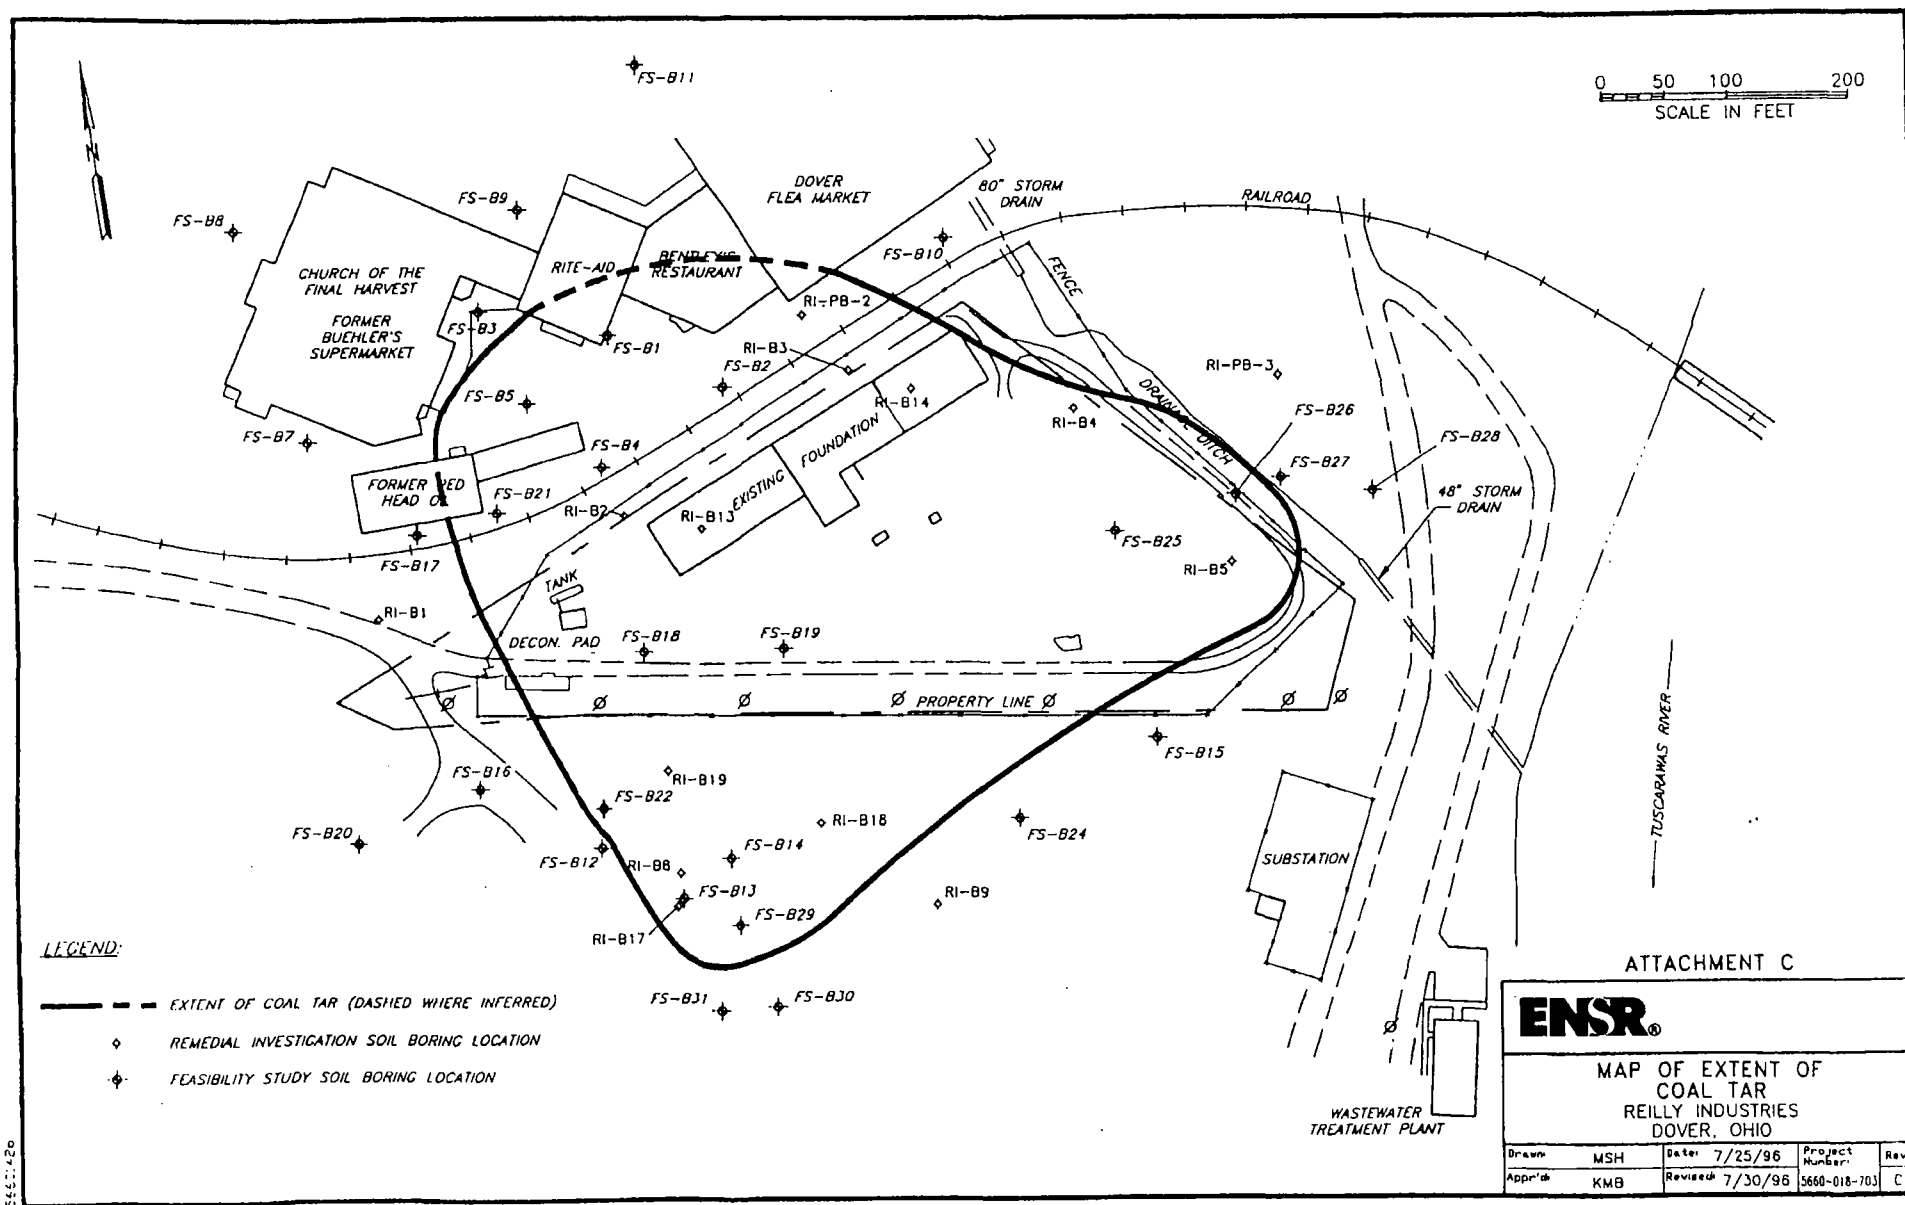
Figure D--Coal tar extent from Technical Memorandum, 1996.
